Power-up February's News

MASTERS ELECTRICAL SERVICES LTD. 4239 W. IH-10 :: SEGUIN, TEXAS 78155

The Case of the Improperly Terminated Motor

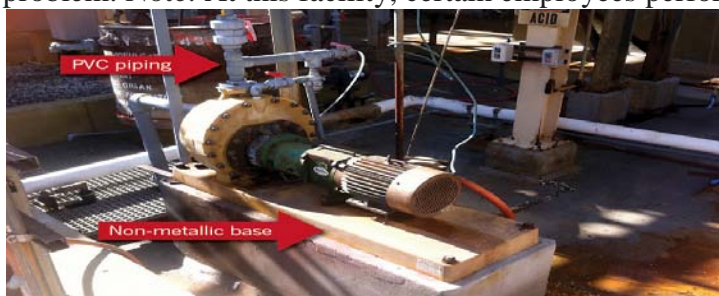
Photo 1. The pump/motor assembly mounted on a non-metallic base and connected to the process through non-metallic piping operated in a hydrochloric acid service environment.

One electrician simply isolated and disconnected the failed motor from the electrical supply so that the maintenance mechanics could remove it, install a replacement motor, and correctly align it to the pump. Another electrician reconnected it. Both men were in-house electricians with several years of experience that took their work very seriously, were considered competent, and always maintained a clear focus on safety. Because the pump was operating in hydrochloric acid service, the pump and motor base, the piping, and all surrounding support were made from non-metallic materials to prevent corrosion. The site, of course, required grounding conductors to all motors, the ground conductor was run with the phase conductors, and was connected to the grounding connection in the motor terminal box, as required by company specifications and applicable codes and standards. At the time, the site did not require additional external equipment grounding conductor, which would have been run external to the conduit/tray/channel that contained the phase supply conductors and grounding conductors, for motors below 200 hp. The motor frame had no external connection to ground either through a separate conductor, piping, or the motor frame. *Note:* Company policy now requires an additional external grounding conductor to be connected to the motor frame in cases where the motor/pump base is made of non-metallic materials.

While troubleshooting the small acid pump, the maintenance mechanic started the motor while leaving his hand on the pump housing, which was connected to the motor frame. Immediately suffering a serious electric shock, the

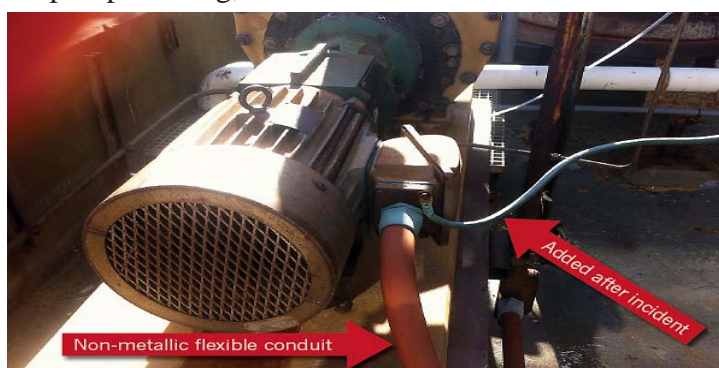
Photo 2. The conduit, containing the phase and grounding conductors, was non-metallic as well. Note: The additional, external grounding conductor shown was added after the incident.

In corrosive environments, it's next to impossible to find materials that are resistant to deterioration; therefore, non-metallic materials are typically used. Due to this fact, an additional external grounding conductor should be provided. After the accident, electrical specifications were reviewed to be sure all similar existing and future installations included an external grounding conductor in addition to the one connected to the motor frame inside the motor terminal box. Adjustments were made and communicated to other plant sites within the company. Special emphasis meetings were also held with electrical and mechanical craftsmen to ensure the technical aspects of the incident were well understood. Lockout/tag out procedures includes verification of proper voltage and current on all phase conductors once the motor is put back in service. The details of this incident, and proper procedures when non-conductive materials are used, are included in the company's electrical safety training. The facility now also requires a color identification test as part of physical exams both for new hires and for routine, periodic exams of existing employees. Although this incident wasn't complicated and no legal action was taken, it did have a serious potential for injury or death. This case demonstrates how important it is for a company to create an environment in which employees feel comfortable discussing personal issues that pertain to their ability to do their jobs efficiently and safely. Similarly, those in management positions who evaluate qualifications and assign jobs also have the same responsibility for proper consideration of such issues.
